# Manhole Inspection Summary

Manhole # S150\_\_009MH

Insp Date: **3/27/08 11:00 AM**

**Location** Address: **2709 LEHMAN ST**

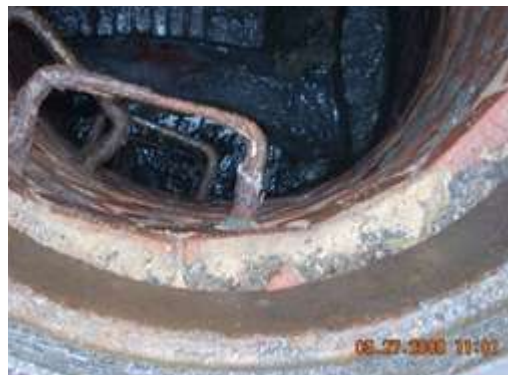
Defect 4

Count: **6** Missing: **0** ☒ **Corroded**

CORRODED STEP

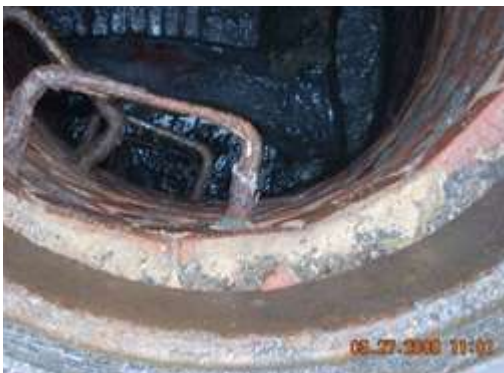
Defect 3

Offset: **2** (in.)

FRAME OFFSET

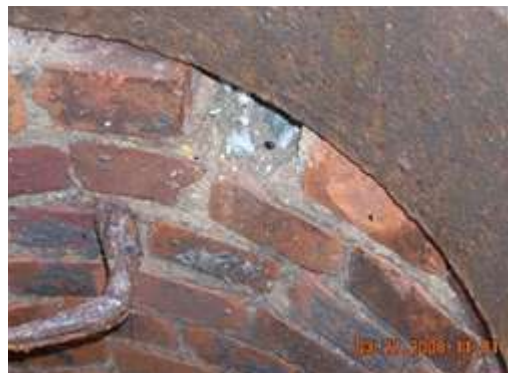
Defect 2

Condition: ☐ Sound ☐ Cracked ☐ Root Intrusion ☐ Loose Brick ☒ **Deteriorated**

Chimney and CORBEL  
DETERIORATION

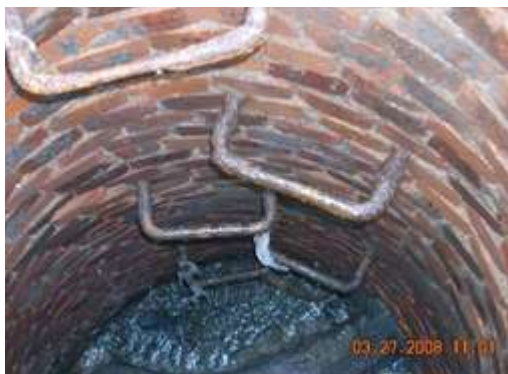
### Defect 1

☒ **Evidence Of Surcharge** Depth: **4** (ft.) ☐ Active Surcharge Present

EVIDENCE OF SURCHARGE ON  
STEPS

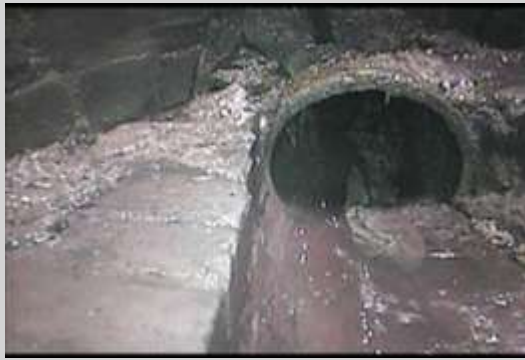
12 O'Clock Outflow

Pipe Height: **7.2** (in.) Rod and Bar (Angled)  
Pipe Material: **Clay** ☐ Pipe Lined  
Invert Depth: **10.91** (ft.) Flow Characteristics: **Slow**  
Deposits: ☐ None ☐ Mud ☒ **Sludge** ☐ Debris ☐ Grease  
Silt Depth: **2** (in.) Deposits Extent: **Light**  
Infiltration: **None** Pipe Seal Cond: **Sound**

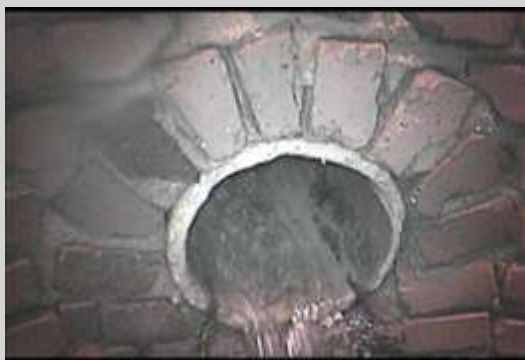
3 O'Clock Inflow

Pipe Height: **8.4** (in.) Rod and Bar (Angled)  
Pipe Material: **Clay** ☐ Pipe Lined  
Invert Depth: **8.42** (ft.) Flow Characteristics: **Slow**  
Deposits: ☐ None ☐ Mud ☐ Sludge ☐ Debris ☒ **Grease**  
Silt Depth: **2** (in.) Deposits Extent: **Light**  
Infiltration: **None** Pipe Seal Cond: **Sound**

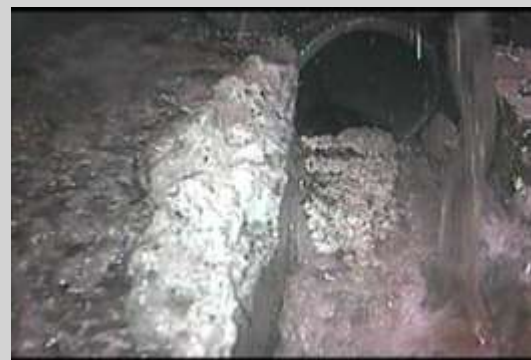
Drop In @ 3 O'Clock

Drop: **Outside** Rod and Bar  
Angled: **Yes** Reading: **9.87** (ft.)  
Inv Depth: **10.87** (ft.)  
Drop Condition: **Clogged**
